# Broadwater Power Project Jetty Replacement, Erosion Control, and Canal Intake Gates

Preliminary Engineering Report

Toston Dam/Broadwater-Missouri Irrigation  
System

*Broadwater County, MT*  
August 20, 2021

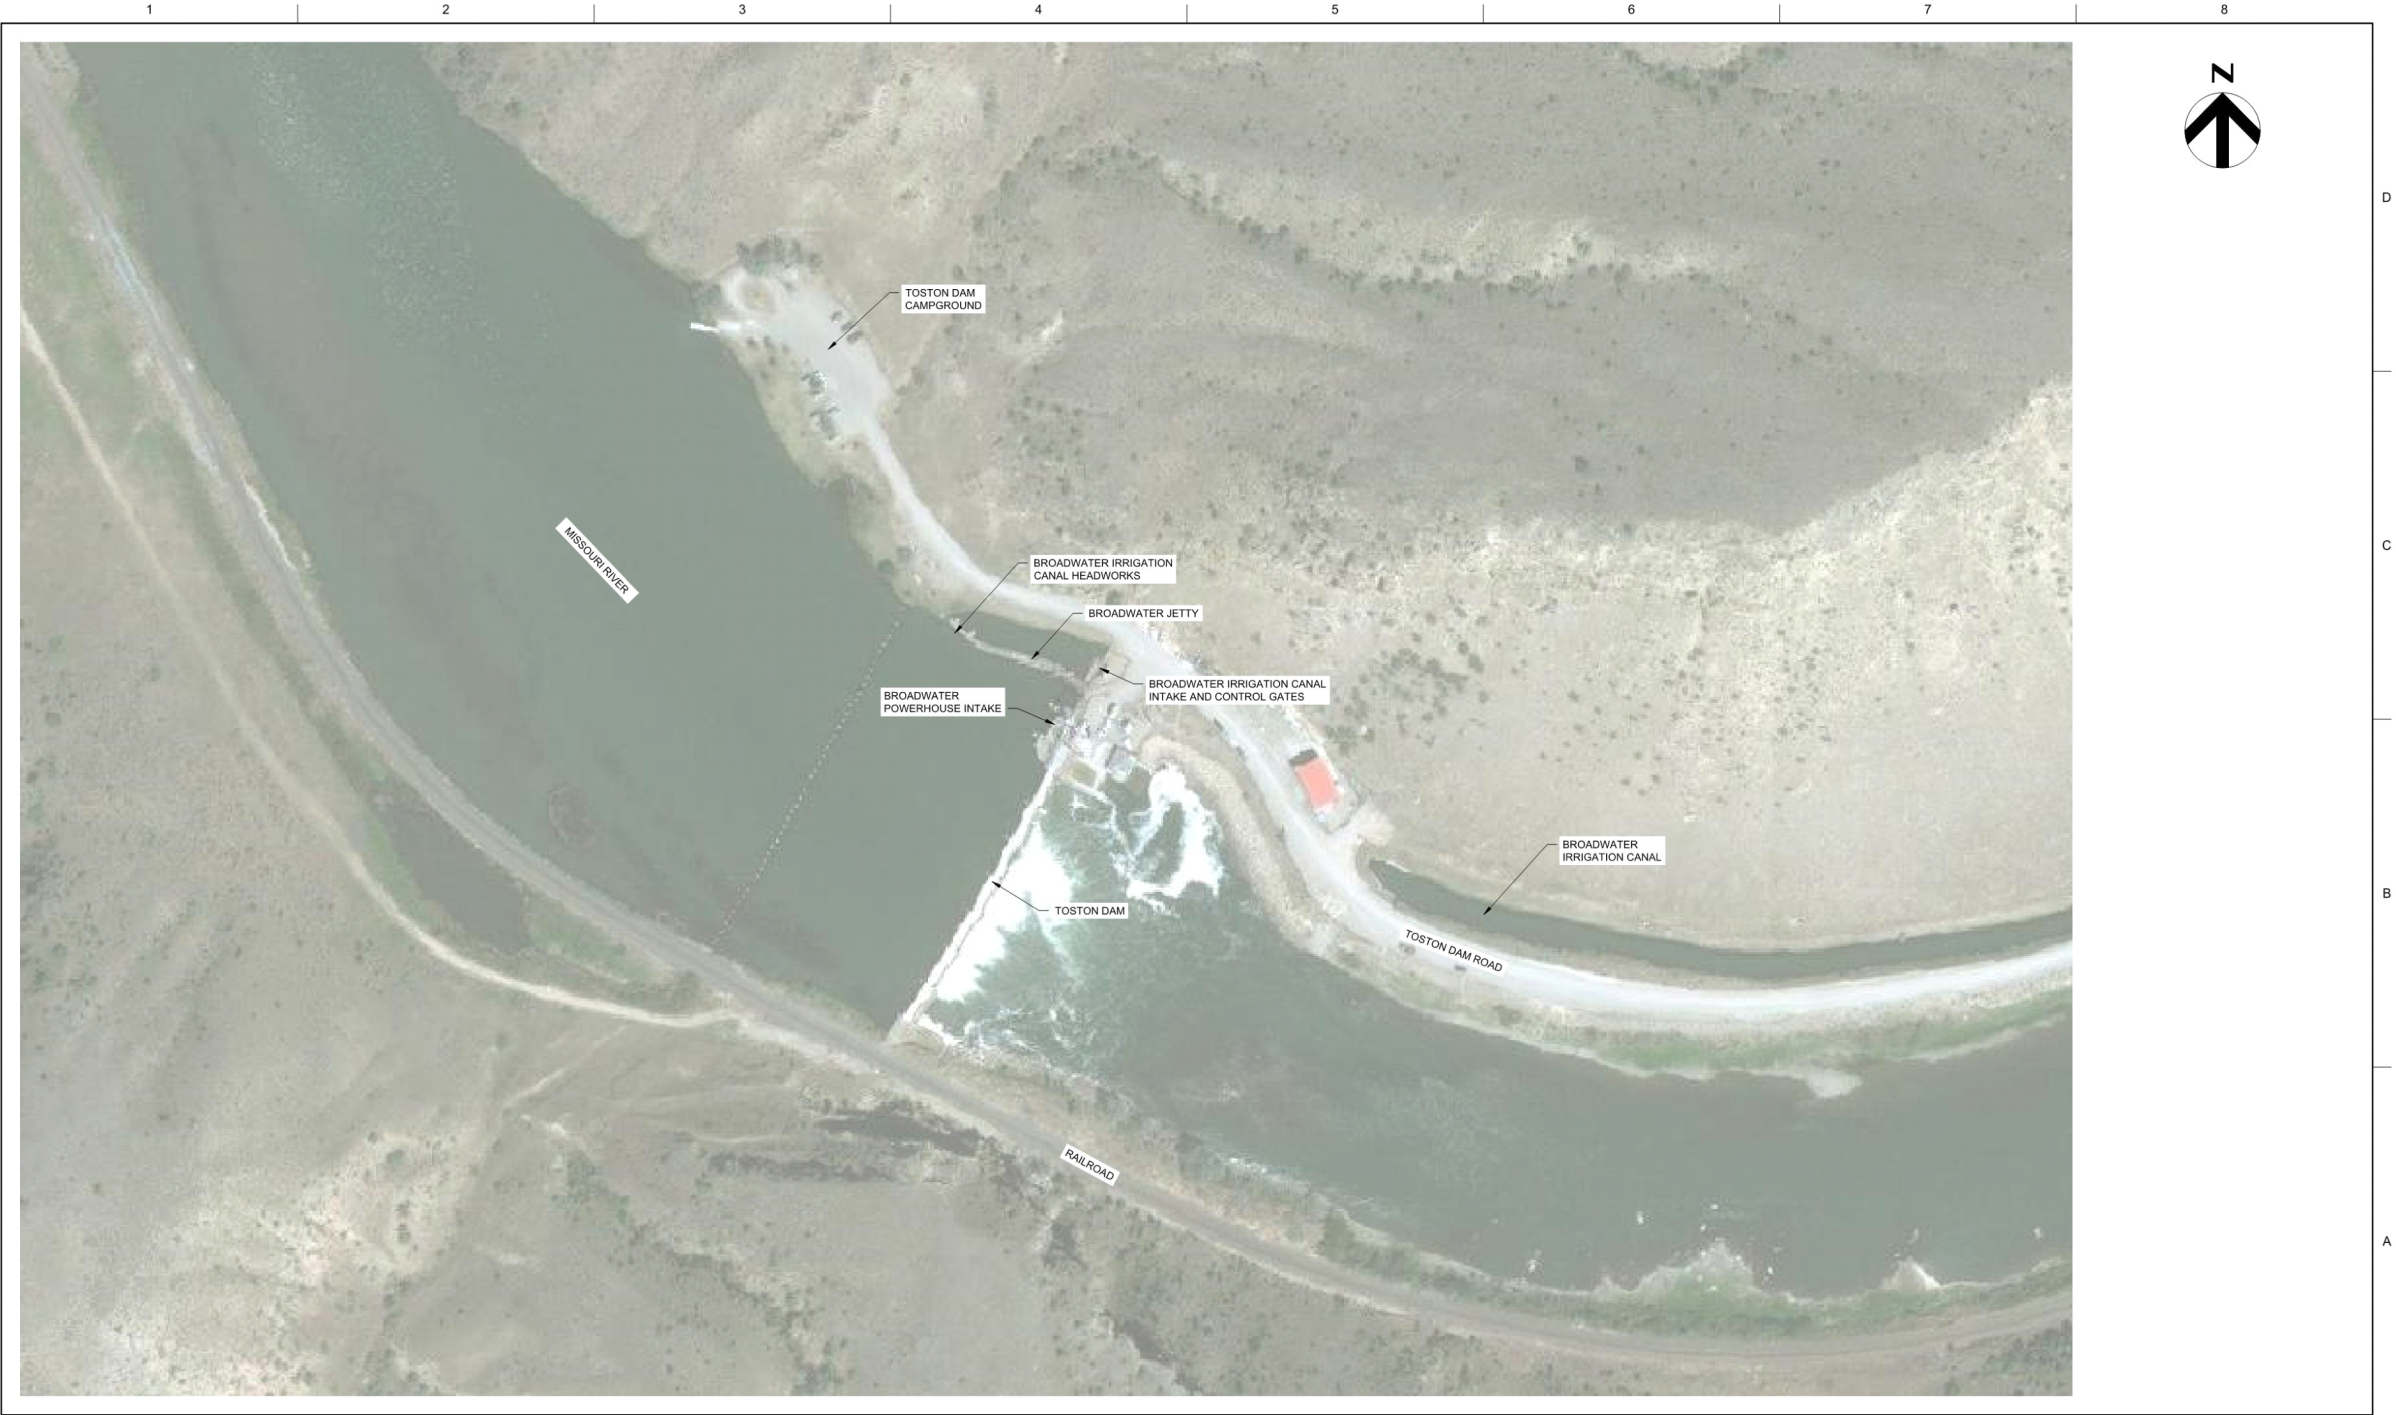
Figure 1-2. Site Map.

The Broadwater Project is located on the Missouri River, near the town of Toston, Montana. The site is approximately 20 river miles downstream of the headwaters of the Missouri and about 20 river miles upstream from Canyon Ferry Reservoir. The project location is shown in Figure 1-1 with site components shown in Figure 1-2

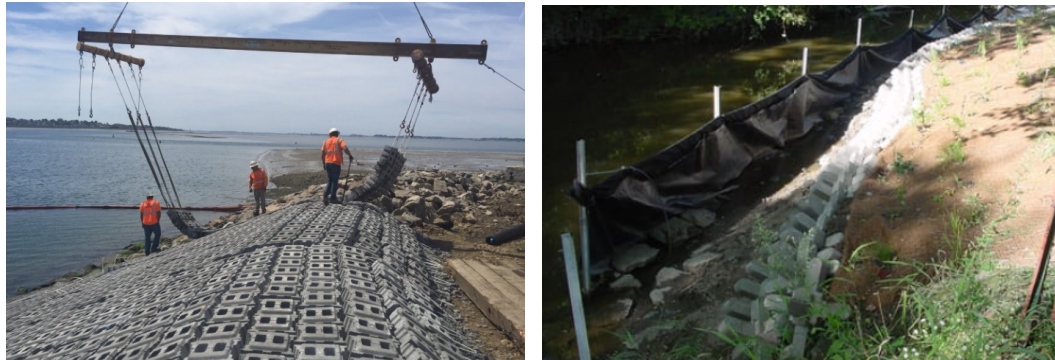
- **Concrete Armor Units (CAU):** This option would consist of the installation of a row of CAUs along the channel slope. For conceptual design, A-Jacks were considered which would be cabled together in interlocking 6x7 foot modules. The A-Jacks would protect from scour and undermining to stabilize the slope, however, they would not armor the entire channel slope. This option could be constructed without lowering of the reservoir; however, divers would be required. A picture of an A-Jack system is shown in Figure 3-4 below.

The ACB revetment would be placed along the channel slope to provide coverage. This option could be constructed without lowering of the reservoir, however, divers would be required. A picture of an ACB mattress being placed as shoreline protection is shown in Figure 3-4 below.

**Figure 3-4. ACB Revetment (Left) and A-Jacks (Right)**

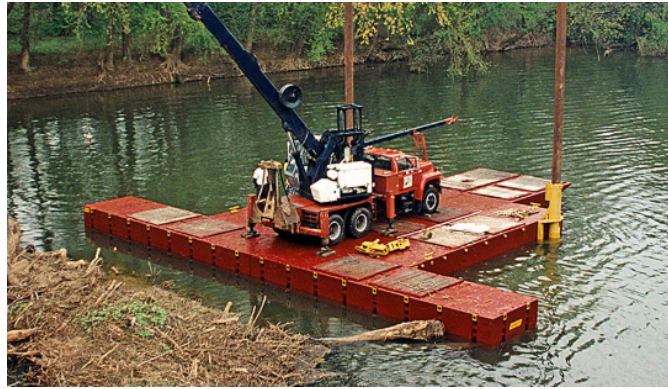
The floating breakwater alternative would be identical to the floating debris barrier, except that it would consist of a floating barge system in place of the floating debris barrier. The floating barge would be placed on the same alignment as the floating debris barrier but would consist of floats capable of supporting equipment. The existing rock jetty would be removed. A barge system with two staggered rows of floats for lateral support for a total width of 20 feet and capable of supporting equipment was assumed for this alternative. An anchoring system for mid-span lateral support of the barge, such as spuds, would be required. Depending on the jetty design/material, the draft would provide some control of suspended floating debris. A Flexifloat barge system with 14 inches of draft and a typical barge layout with spuds are shown in Figure 3-7 and Figure 3-8, respectively. Similar to the floating debris barrier, as a result of the floating barge draft, channel bottom velocities under the floating barge may increase. A new cast-in-place concrete sill/weir is assumed for this alternative.

**Figure 3-7. Example of Flexifloats Used to Create a Floating Barge.**

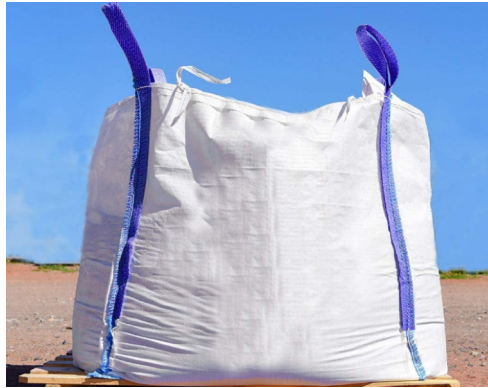
The FIBC jetty alternative would consist of the reconstruction of the existing jetty with flexible intermediate bulk containers filled with concrete. The existing jetty would be removed to the extent required for foundation stability. Bedding stone would be placed and FIBCs filled with concrete would be stacked to form a new jetty approximately in the same location as the existing jetty. 1 cubic yard FIBCs with a lifting capacity of 4,000 lbs for the placement of 1 cubic yard of concrete were assumed for this alternative. Without lowering of the reservoir, divers may be required to assist during FIBC placement. Due to the limited life expectancy of the FIBCs, the bags would be sacrificial and would deteriorate, leaving the concrete material behind. A FIBC sack and typical section for the jetty are shown in Figure 3-10 and Figure 3-11. Detailed FIBCs jetty design and layout, as well as an evaluation of alternative jetty alignments to maximize debris control and cost effectiveness, would occur if this alternative is selected.

**Figure 3-10. Typical FIBC.**

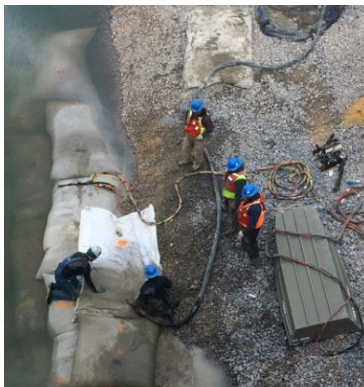
The grout jetty alternative would consist of the reconstruction of the existing jetty with submerged grout bags filled with concrete. The existing jetty would be removed to the extent required for foundation stability. Grout bags would then be set on the bottom and a tremie would be utilized to fill the grout bags with concrete through a self-closing fill port. The new jetty would be at approximately the same locations as the existing jetty. Grout bags are available in sizes up to 220 cubic yards and could also be customized to incorporate internal structural elements for vertical sides. Standard 10x6x1.5 feet grout bags were assumed. Typical grout bags and placement, and a typical section for the jetty are shown in Figure 3-12 and Figure 3-13.

**Figure 3-12. Sythetex Grout Bags and Placement**

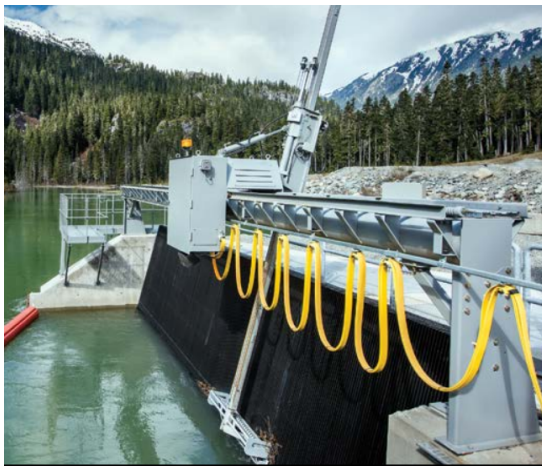
The trash rake system would be comprised of an automated trash rake controlled by a programmable logic control (PLC) system which could be set to manual, automatic, or continuous operation. The trash rake would deposit debris onto the deck behind the trash rake or a conveyor system which would convey debris to a common location for collection and removal. The trash rake system could be hydraulic or electromechanical. For this conceptual design, an electromechanical system with a 700-pound lift capacity was assumed. The final trash rake system design would be based on the size, type, and quantity of debris to be removed and would occur if this alternative is selected. Two possible types of trash rake system are shown in Figure 3-15 and Figure 3-16. For channel stabilization following removal of the existing jetty, a 50x60 foot underwater ACB revetment system would be constructed, with additional details provided in Section 3.5.

**Figure 3-15. Atlas Polar (Hydraulic) Trash Rake System**

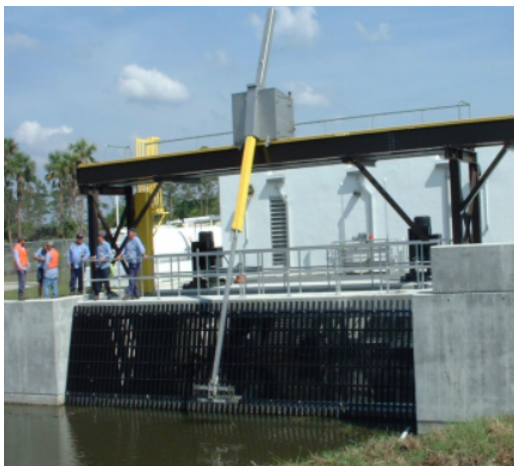
**Figure 3-16. Hydro Components System (Electromechanical) Trash Rake System**

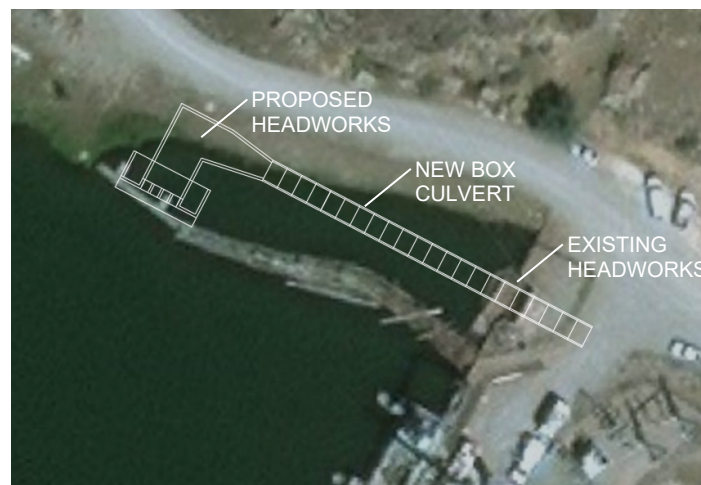
A new cast-in-place concrete headworks structure would be constructed and oriented at an angle rotated approximately 90 degrees from the existing headworks to provide increased protection from debris. The proposed headworks alignment is preliminary and would be optimized if this alternative is selected. The new headworks structure would have four bays equipped with 48x87 inch manually operated stainless steel slide gates protected by trash racks. The gates could be automated, however, manually operated gates were assumed. The new headworks would include safety features and a new concrete sill and cutoff wall in front of the structure. The structure would be designed with a 90-degree bend downstream of the slide gates for tying into the box culvert with internal walls and vanes to reduce head losses. Total head requirements and losses would need to be evaluated to verify the capacity to deliver required irrigation diversions. This, as well as detailed design of the headworks, box culvert, and appurtenant features, would occur if this alternative is selected. A schematic layout of the headworks for this alternative is shown in Figure 3-18, with a more detailed conceptual layout presented in Appendix J.

**Figure 3-18. Relocate Irrigation Headworks Upstream Layout**

Extension of the box culvert and construction of the new headworks structure would require extensive rebuilding of the bank into the reservoir. The reconstructed bank would be armored with riprap. Without lowering of the reservoir, extensive dewatering would be required to facilitate construction of this alternative. For channel stabilization following removal of the existing jetty, a riprap apron would extend 30 feet from the sill of the headworks. Additional details on channel stabilization and the ACB revetment system are provided in Section 3.5.

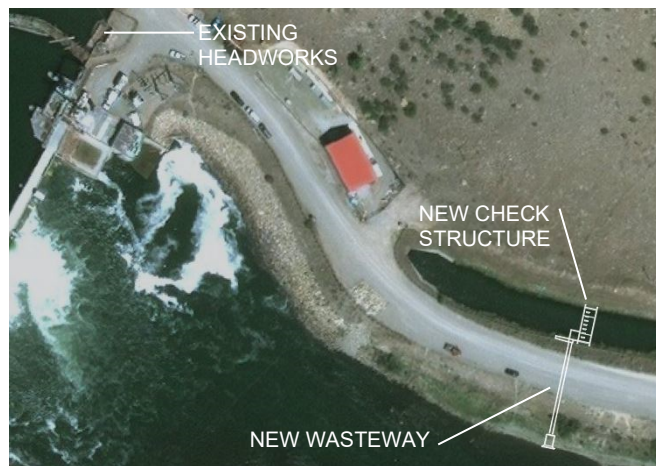
The check structure would have standard four-foot bays with stoplog guides which would accommodate 48 inch manually operated slide gates. Different gate types and configurations could be considered, and the gates could be motorized and automated. It is assumed that the existing headworks would provide the primary means for debris control. The existing trash racks would be left in-place and a floating debris barrier would be installed upstream. The existing slide gates could be left in-place or removed. If removed, dewatering of the downstream canal would be more difficult. A new wasteway structure comprised of an overflow crest and 42-inch slide gate which would outlet to a 42 inch reinforced concrete pipe would be constructed upstream of the check structure to allow for the sluicing of sediment and debris. A baffled outlet structure at the river would provide energy dissipation. The structures would be equipped with standard safety features. Detailed design of the structures and all appurtenant features would occur if this alternative is selected. A schematic layout of the new check structure and wasteway is shown in Figure 3-19 with more detailed conceptual layout presented in Appendix K.

**Figure 3-19. Relocate Irrigation Headworks Downstream Layout**

Moving of the headworks downstream would require raising of the roadway and canal embankment upstream of the new check structure due to the increased water elevation upstream of the check structure. The box culvert design would be reviewed for the new operating conditions and lining of the canal may be required to prevent excessive seepage resulting from the raised water surface elevation. For channel stabilization following removal of the existing jetty, a 50x60 foot underwater ACB revetment system would be constructed, with additional details provided in Section 3.5.

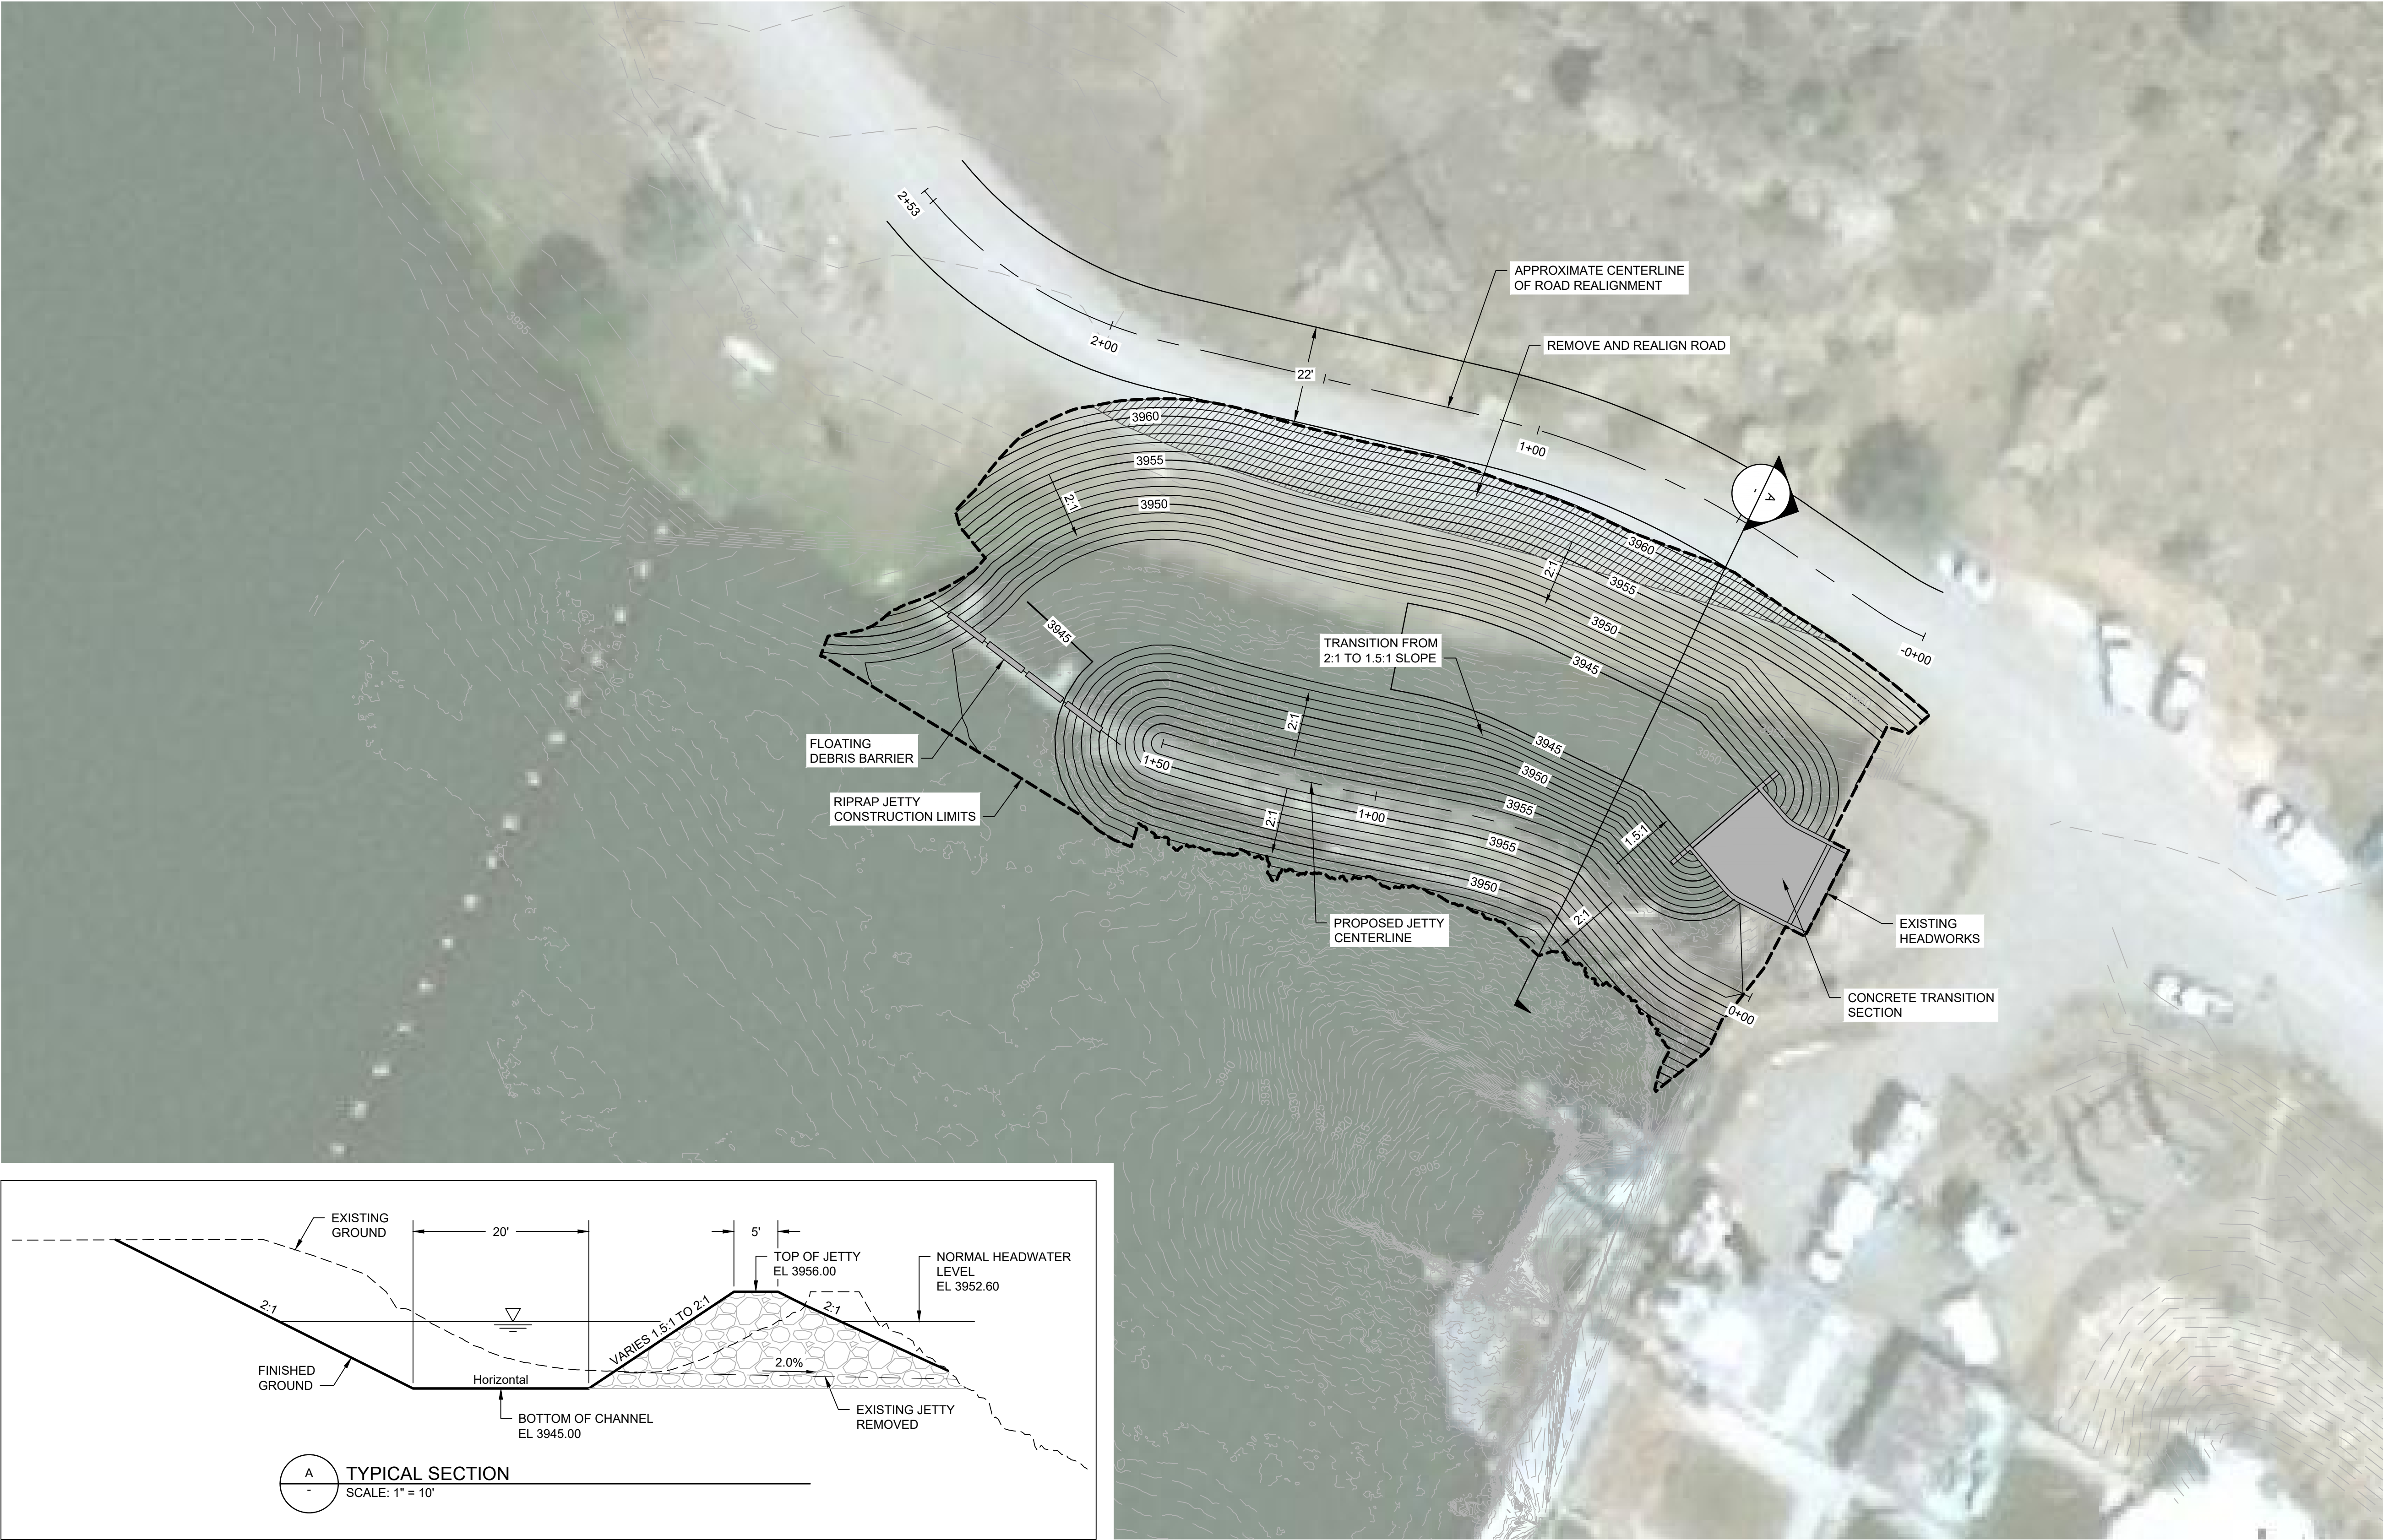
SHEET  
01C-ALT2

## Appendix F. Riprap Jetty Conceptual Layout

A  
TYPICAL SECTION  
SCALE: 1" = 10'

This alternative included removal of the existing jetty and replacement of the jetty with gravity type jetty. Various jetty material options i.e. rip rap, concrete blocks, ACBMs, super sacks, gabion baskets, geotextile tubes or mats, would likely have similar configurations and functionality. It is assumed the existing jetty needs to be fully removed because it does not provide a competent foundation for any of the reconstruction alternatives. Analysis of which material used to construct a gravity style jetty should be performed only if this alternative is chosen as the preferred alternative.

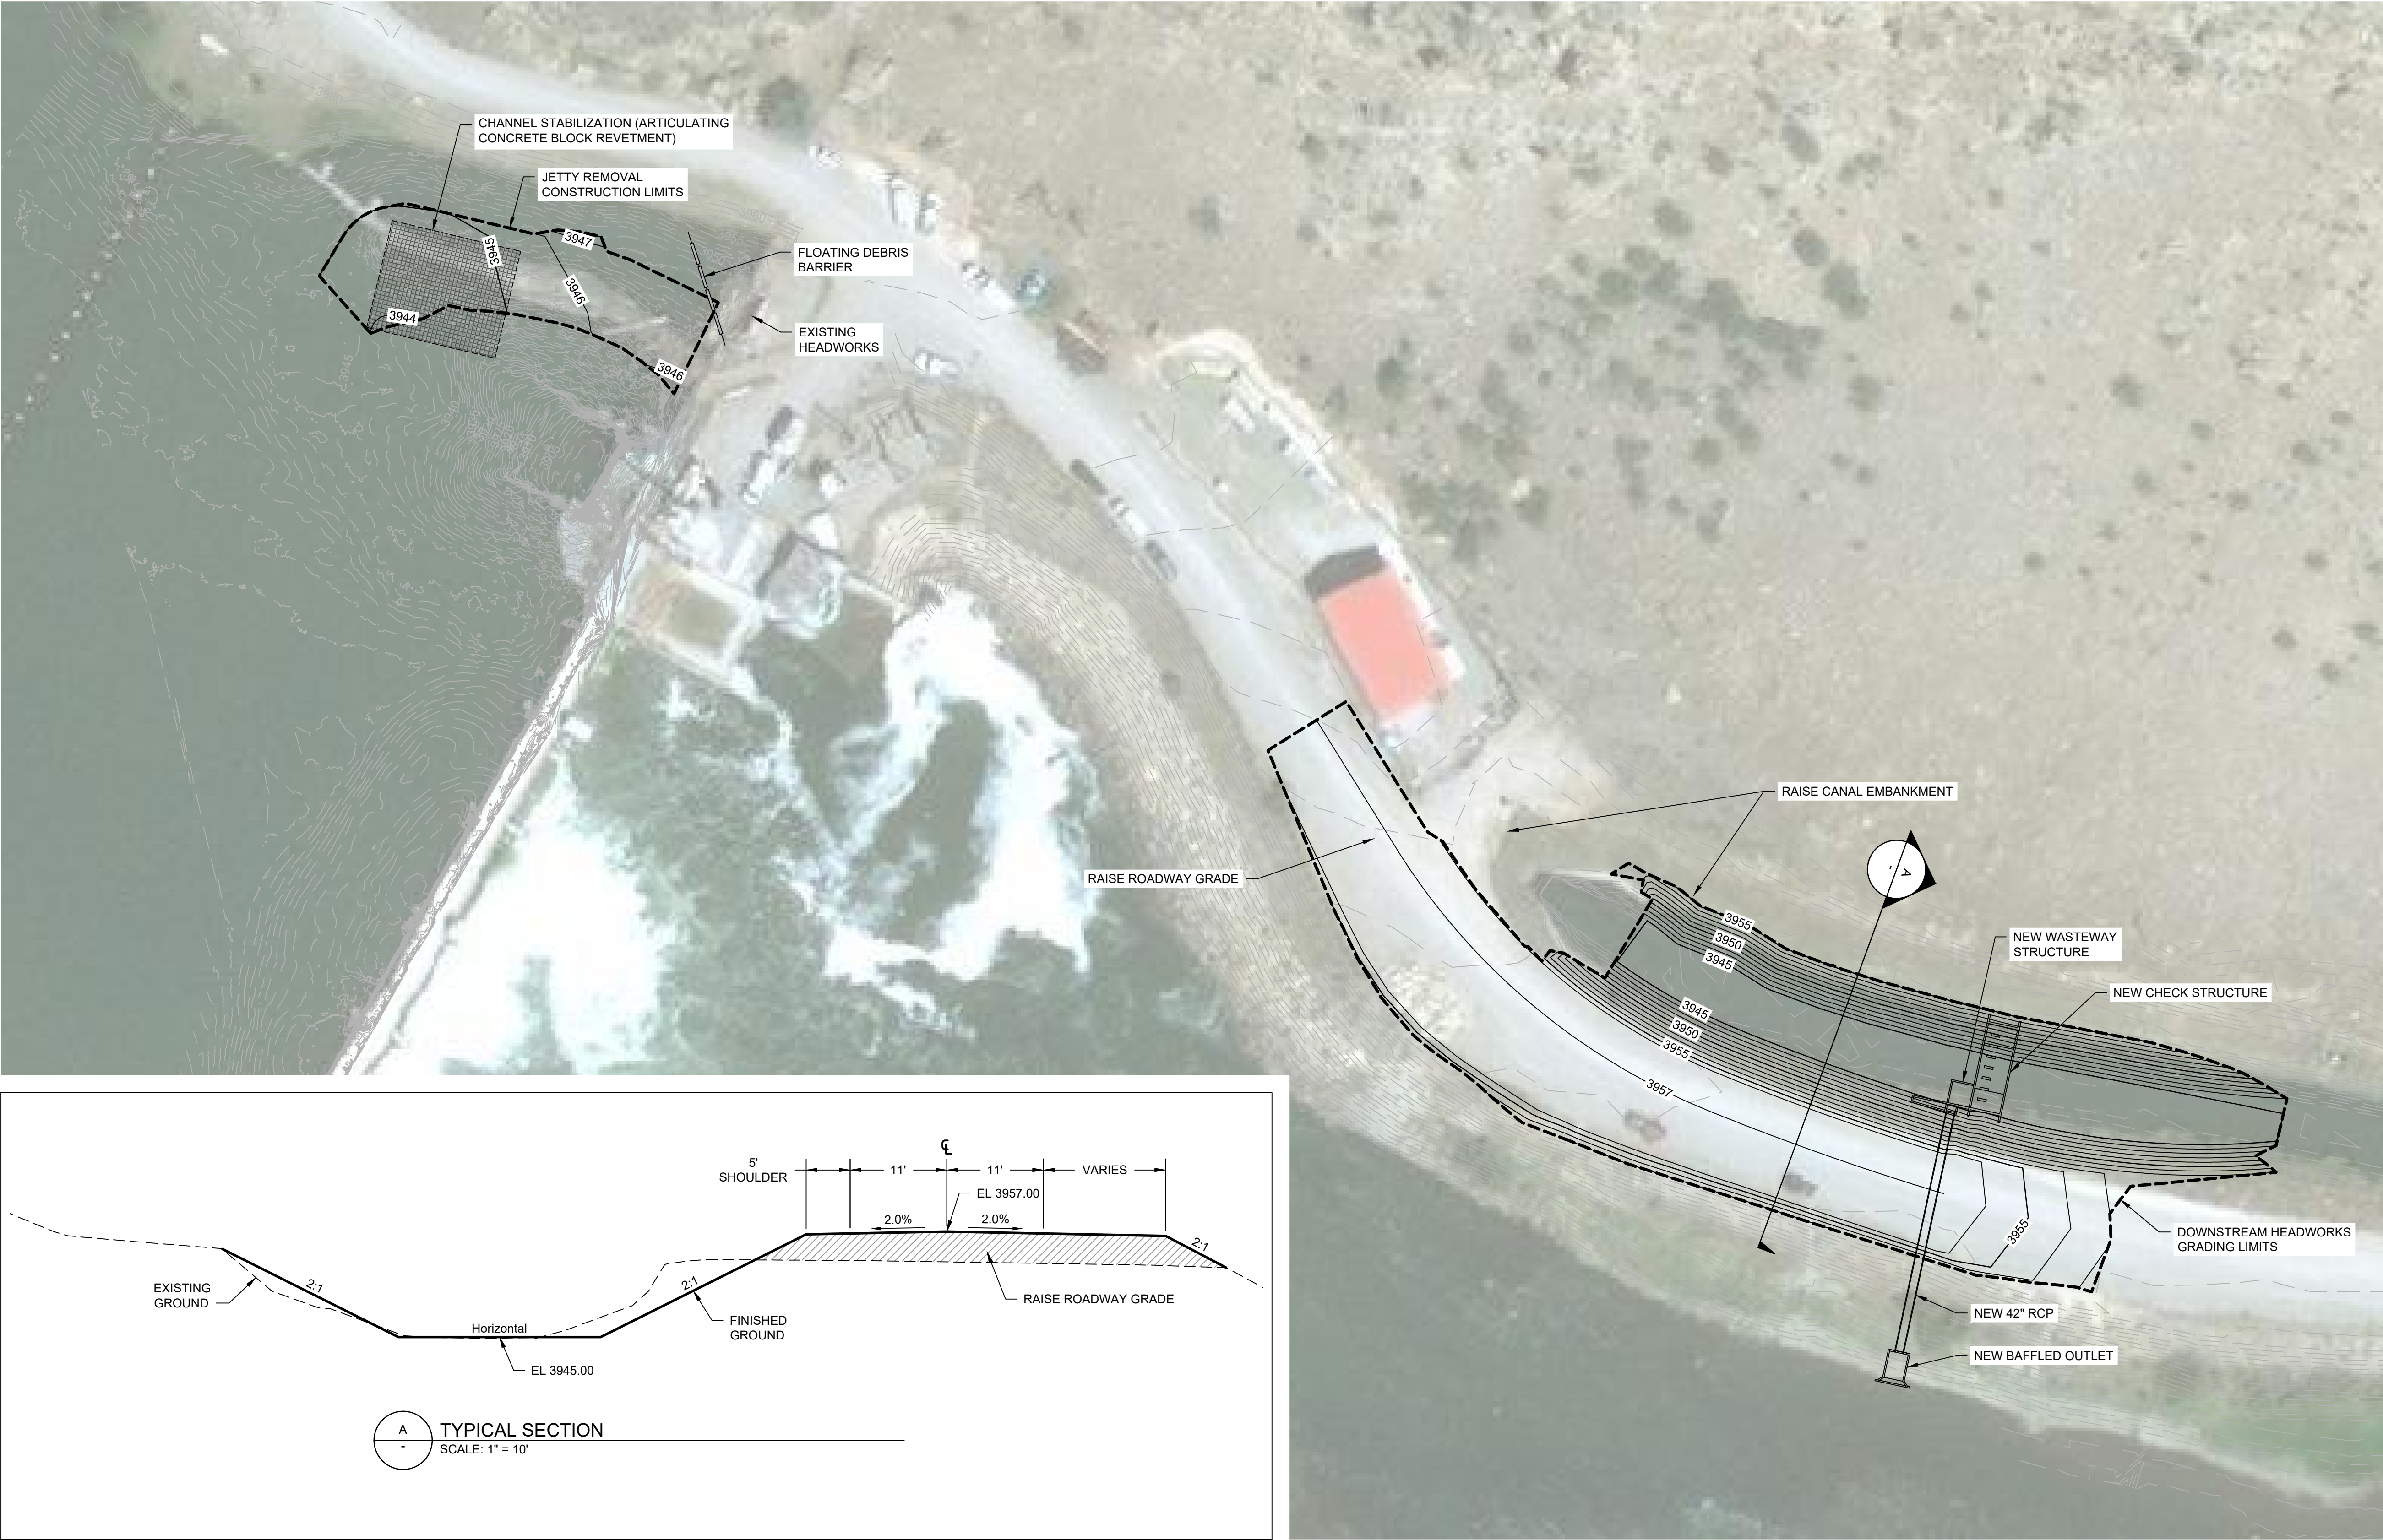
## Appendix K. Relocate Irrigation Headworks Downstream Conceptual Layout
